Comfortspec Home Inspection Services

Property Inspection Report

123 Mockingbird Lane, Niceville, PA 12345
Inspection prepared for: Happy Homebuyer
Real Estate Agent: Best Agent - One Professional Realtor

Date of Inspection: 4/23/2015 Time: 1:00 PM
Age of Home: 2005 Size: 2896
Order ID: 2949

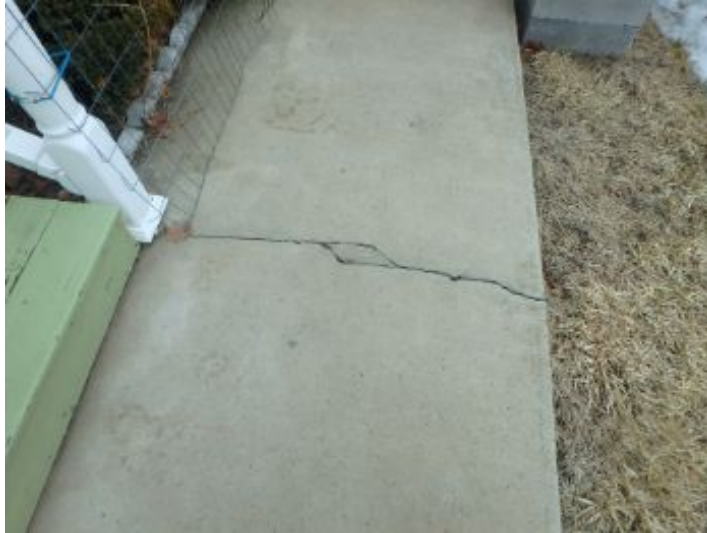
2. Walkways

- Settling concrete slab area with cracks where walk meets front. Water can intrude and affect the foundation. Repair as needed.

Settling concrete slab area with cracks where walk meets front. Water can intrude and affect the foundation. Repair as needed.

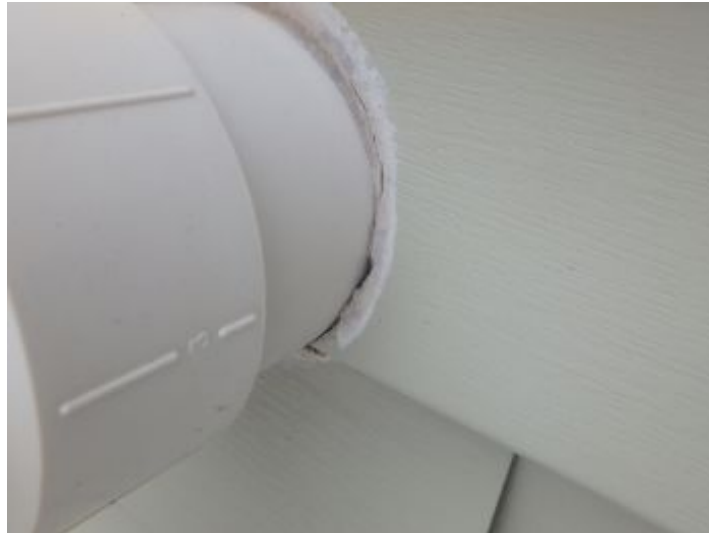
5. Exterior Caulking

Recommend sealing all utility penetrations/masonry ledges/around windows and any other open seams.

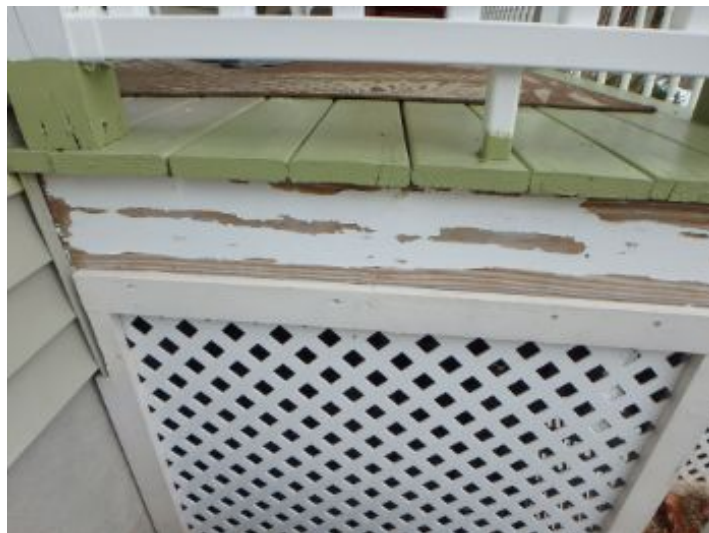
6. Soffits, Fascia and Trim

Recommend routine exterior painting maintenance of any exposed wood surfaces as needed.

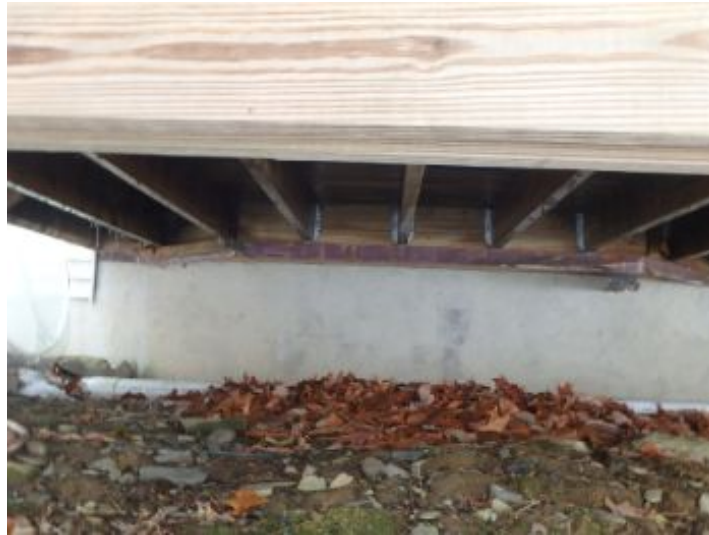
7. Deck, Balcony

- The deck was installed with joist hangers and ledger bolts. This is a standard not always followed.
- Appears in satisfactory and functional condition with normal wear for its age. Appears to be sound structure.
- Peeling paint observed. Recommend repainting/staining where needed.

The deck was installed with joist hangers and ledger bolts. This is a standard not always followed.

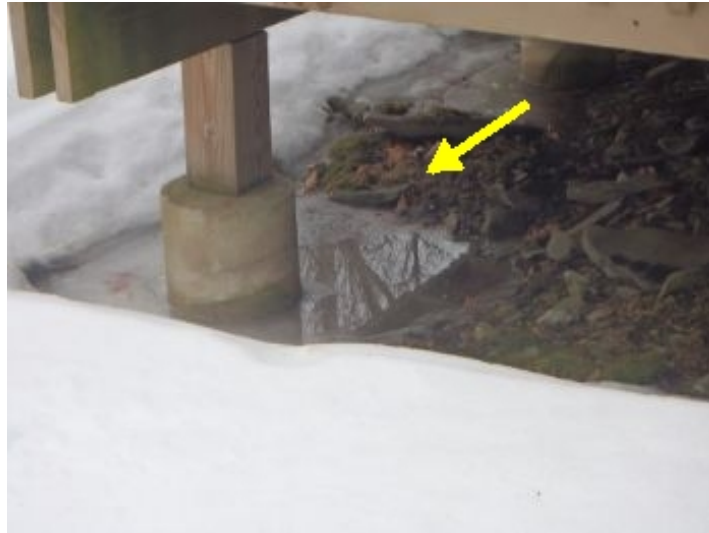
9. Grading and Surface Drainage

Description: Grading is away from house except rearyard, which slopes towards the home.

There are some low spots along the deck footers. Recommend Regrading to allow for proper drainage.

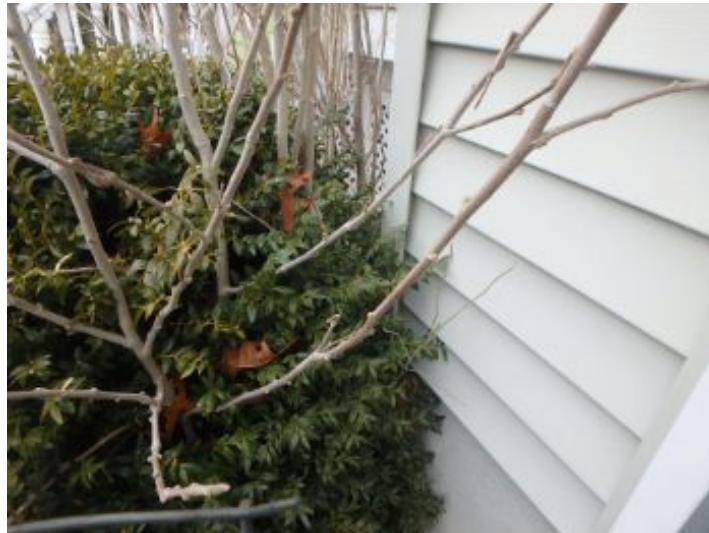
10. Vegetation Affecting Structure

Vegetation is currently away from home. Recommend continued maintenance assuring home is free of contact with vegetation.

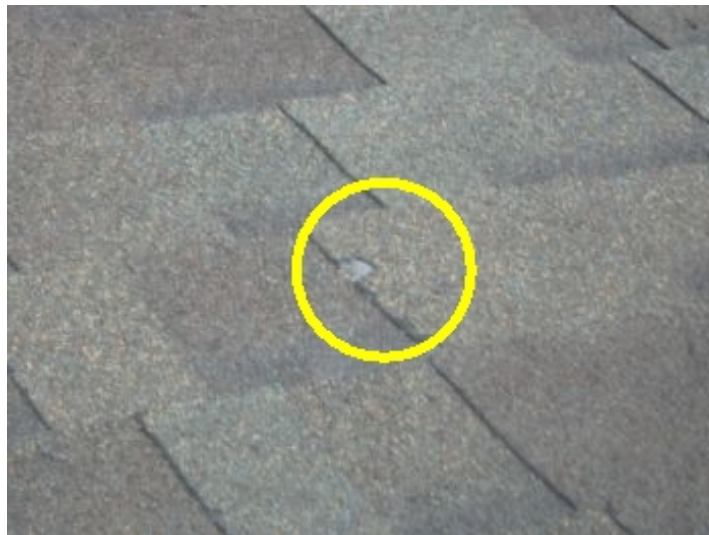
3. Roof Covering

Age: 10-15+ years • 1 visible layer observed

Roof is serviceable. A roof tune up including patching broken shingles and cleaning should be performed to aid in lengthening the replacement and help prevent the chances of premature leaking.

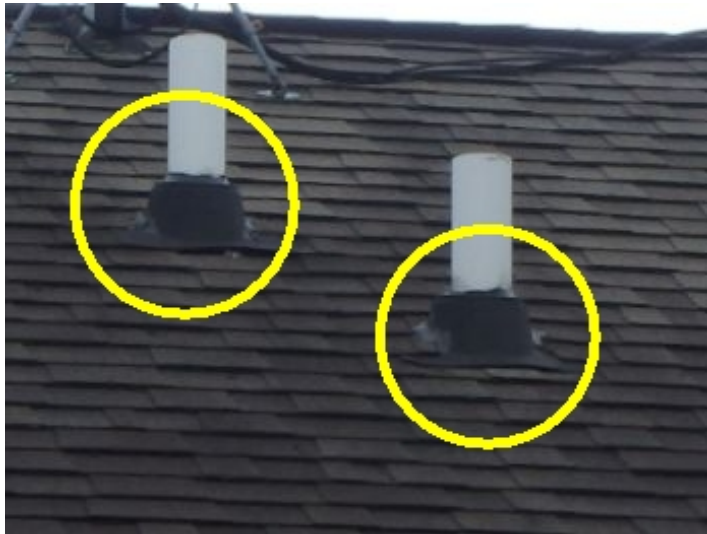
5. Roof Penetrations

One or more roof penetrations have been sealed with tar or mastic instead of conventional metal or plastic flashings. Leaks may develop over time as the sealant deteriorates. The penetrations will need to be diligently monitored for leaks and periodically re-sealed. Replacement of the flashing is a better alternative and is recommended.

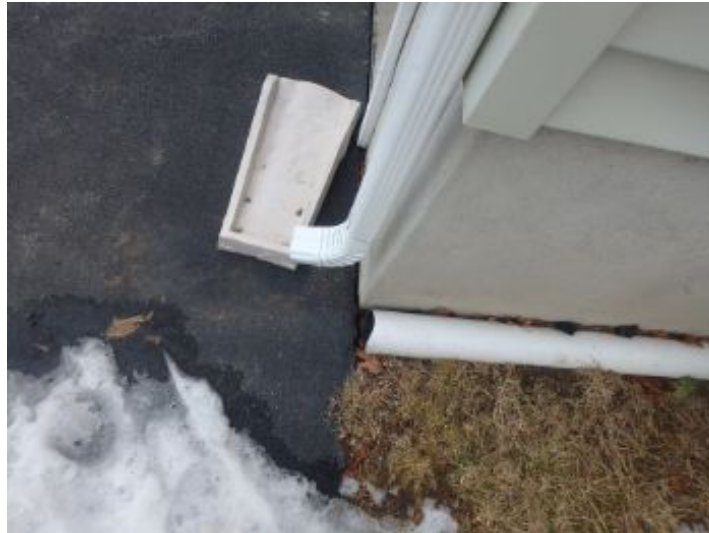
7. Roof Drainage System

Description: Galvanized/Aluminum • All downspouts discharge above grade

Downspouts which discharge onto the ground - above grade - should discharge a good distance away from the house -- four (4) to six (6) feet or more, if possible. The slope of the ground in this area should be away from the house to direct water away from the foundation.

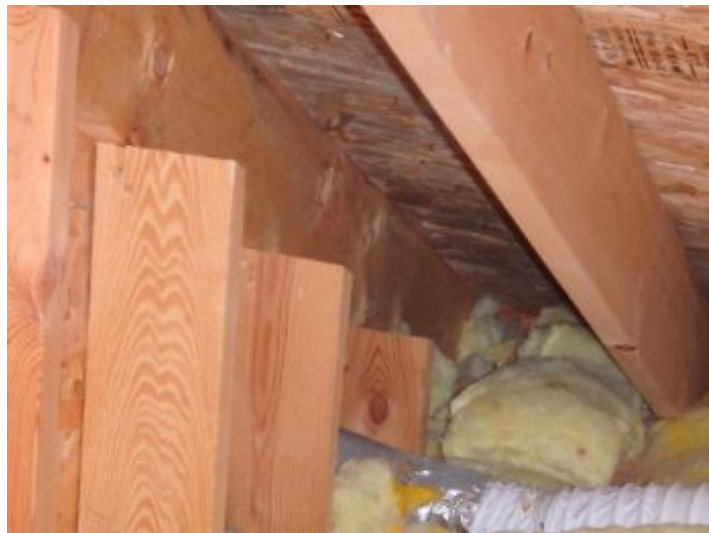
<i>Structure</i>		
Page 10 Item: 8	Ceiling and Roof Structure	<ul style="list-style-type: none"> • Staining was observed at the roof sheathing located in the attic. This is typically from the ventilation or insulation systems. The staining may contain mold. Recommend contacting a remediation specialist for treatment.
<i>Electrical</i>		
Page 18 Item: 4	Main Service Panel(s)	<ul style="list-style-type: none"> • "Double Tapping" observed on one or more circuit breakers--two wires on single breaker. This will cause nuisance tripping. Qualified electrician should evaluate and repair as necessary.
Page 19 Item: 7	Overcurrent Protection	<ul style="list-style-type: none"> • Oversized breakers in main panel. The wire supplying the breaker is too small for the breaker. This should be evaluated and corrected by a qualified electrician.
Page 21 Item: 11	Smoke/Heat Detector(s)	<ul style="list-style-type: none"> • Battery in smoke detectors were missing. New batteries were installed as a courtesy by inspector.

Staining was observed at the roof sheathing located in the attic. This is typically from the ventilation or insulation systems. The staining may contain mold. Recommend contacting a remediation specialist for treatment.

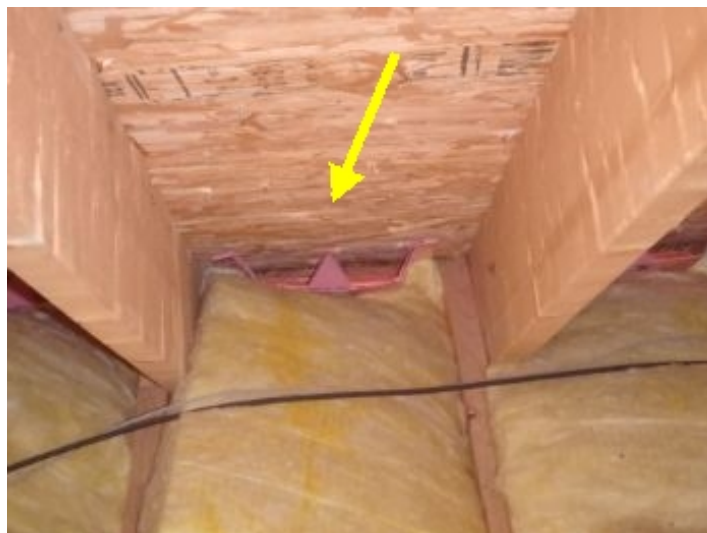
Baffles are installed. These allow air flow through the attic which is required to prevent moist, stagnant air from infiltrating the attic and prevents ice damming.

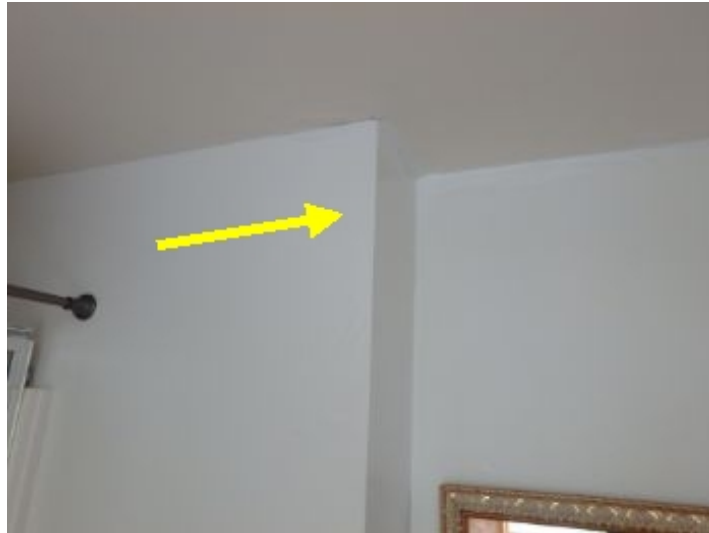
Moisture intrusion noted at master bath and dining room ceiling. Unable to determine the condition of the underlying material due to the homes finishing system. Recommend further evaluation by a qualified contractor. The master bath was dry at the time of inspection and appears to have been corrected.

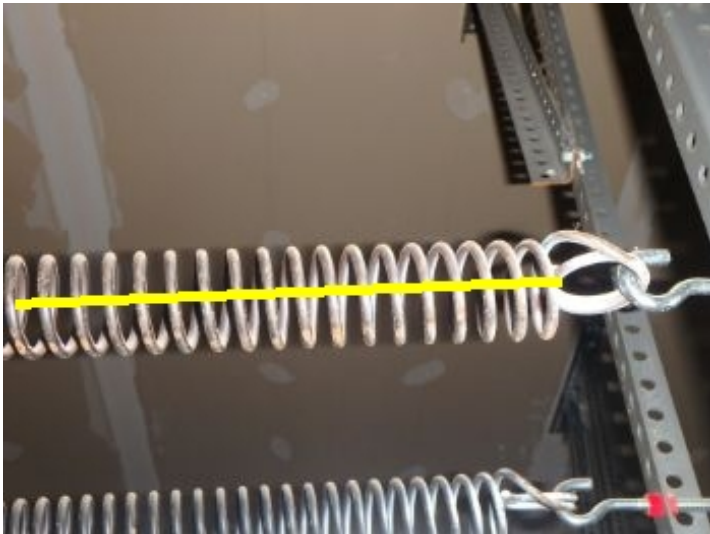
Safety cable passing through springs not present. This is an easy upgrade and recommended for additional safety.

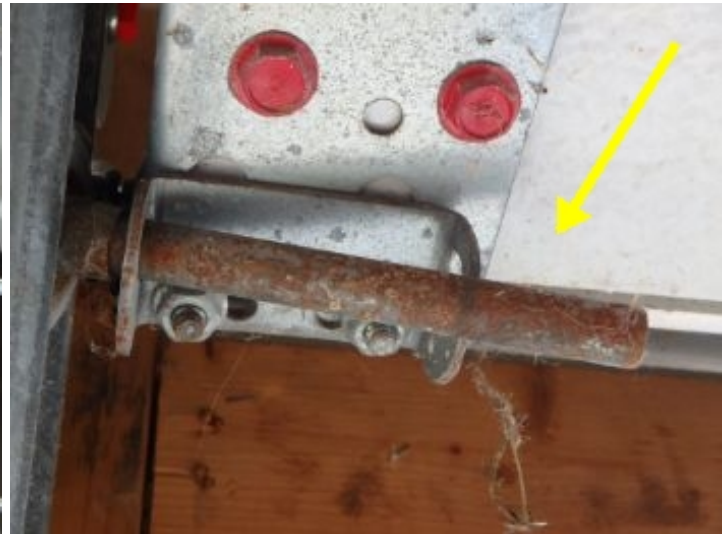
Right door bottom roller not in place. This is an easy fix that can be handled by a qualified handyperson.

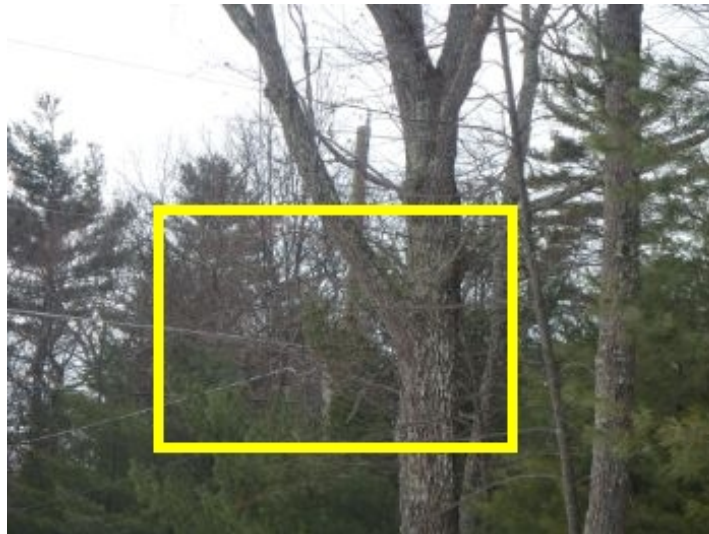
Wires are touching trees, recommend trimming trees as necessary to prevent damage to wires.

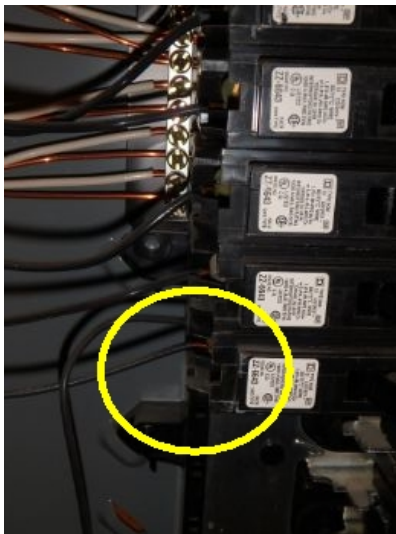
"Double Tapping" observed on one or more circuit breakers--two wires on single breaker. This will cause nuisance tripping. Qualified electrician should evaluate and repair as necessary.

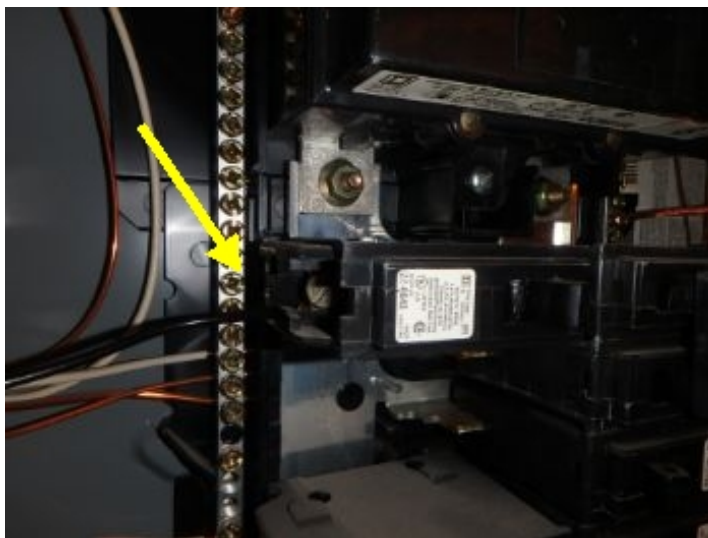
Oversized breakers in main panel. The wire supplying the breaker is too small for the breaker. This should be evaluated and corrected by a qualified electrician.

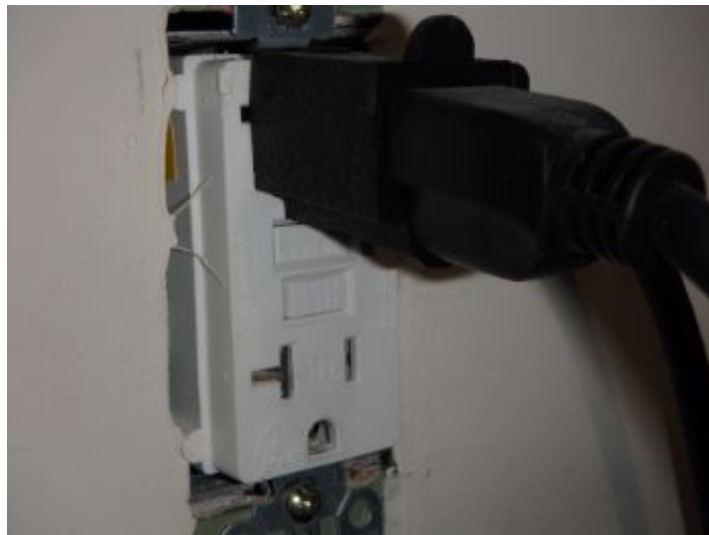
Missing cover in basement.

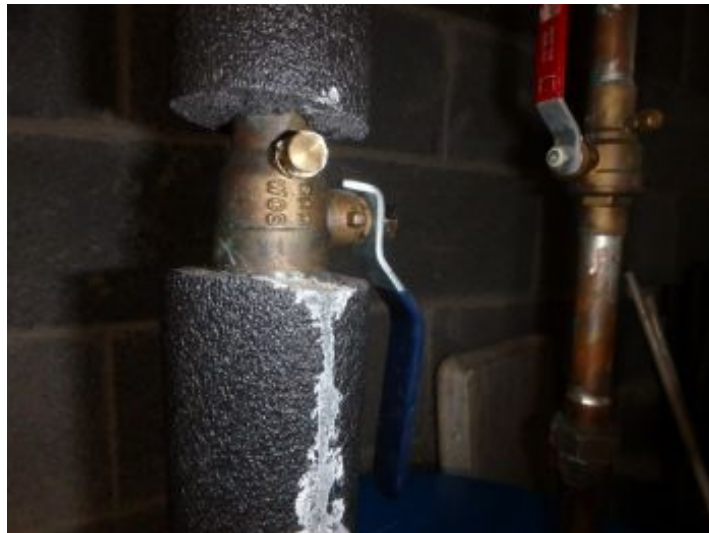
Indications of previous leaking evident by oxidation over water heater. This should be monitored for future concerns.

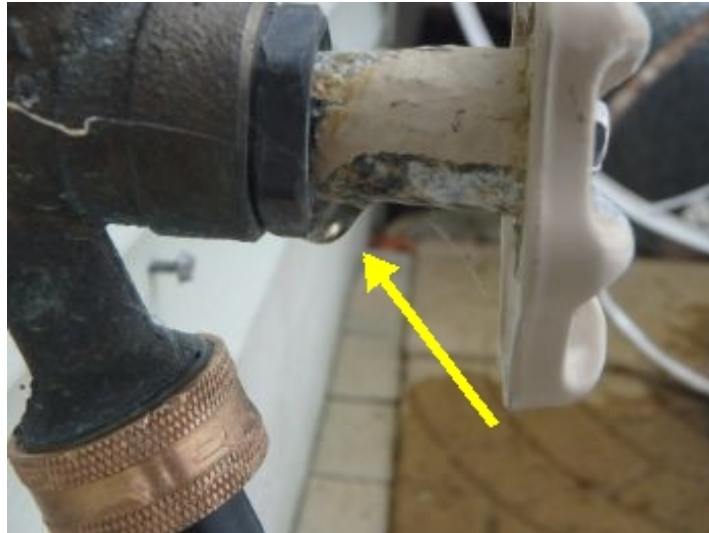
rear hose bib was leaking. Repaired by inspector.

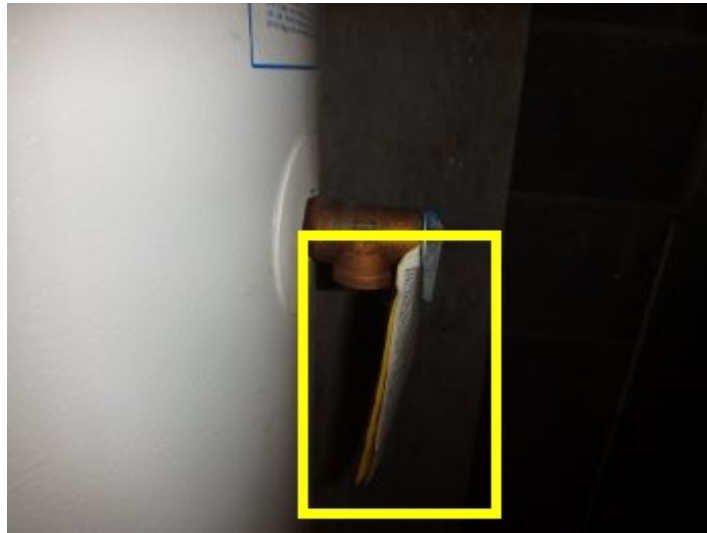
The extension at the water heater relief valve is missing. This is a potential scalding concern as water can discharge improperly. Recommend installing the proper type of relief extension to discharge within 6" from the floor.

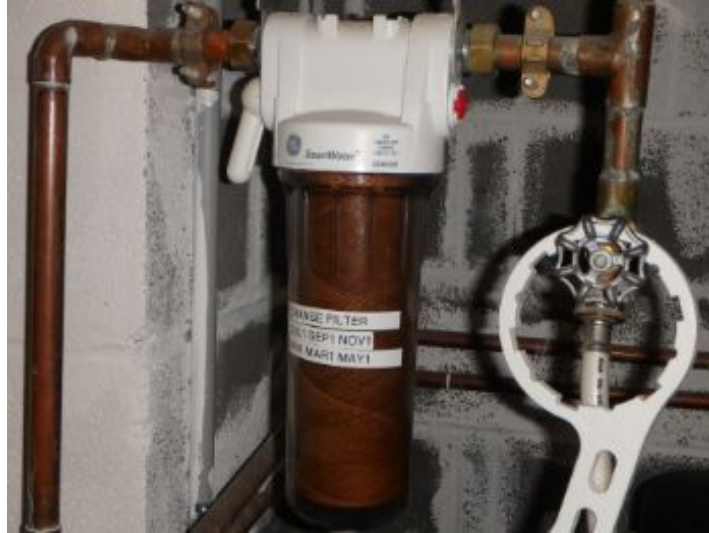
Recommend replacing water filter every 2 months or as needed.

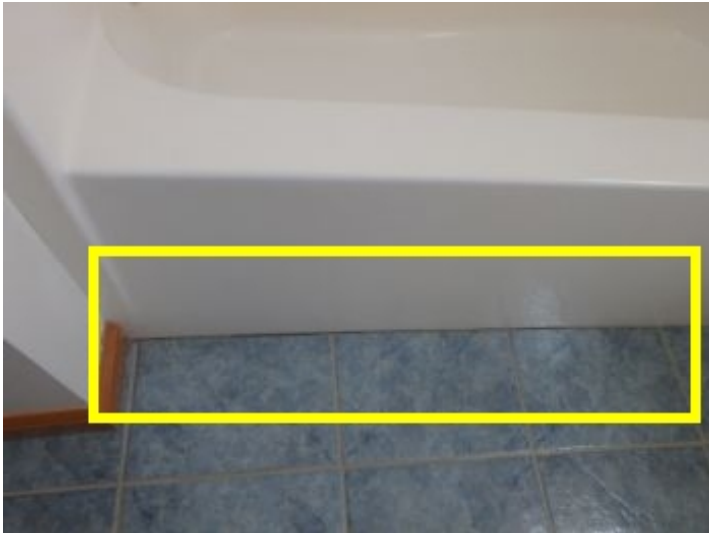
Some caulking repair needed at tubs. Caulking reduces the amount of moisture penetration around the tub. Recommend resealing all tub seams.

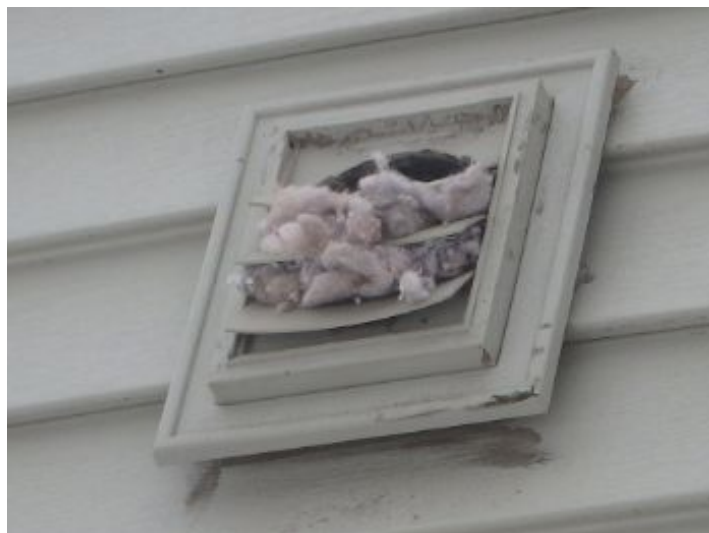
Dryer duct was plugged. Cleaned by inspector as a courtesy.
