Comfortspec Home Inspection Services

Property Inspection Report

123 Mockingbird Lane, Niceville, PA 12345
Inspection prepared for: Happy Homebuyer
Real Estate Agent: Best Agent - One Professional Realtor

Date of Inspection: 4/23/2015 Time: 1:00 PM
Age of Home: 2005 Size: 2896
Order ID: 2949

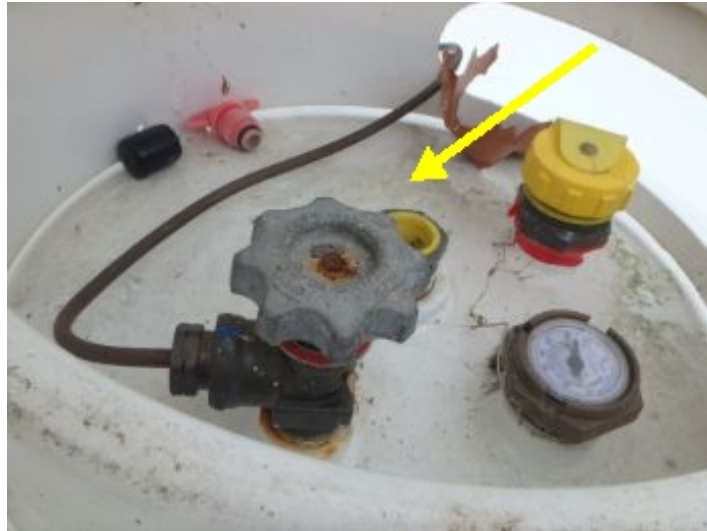
- Propane shutoff.
- No deficiencies noted.

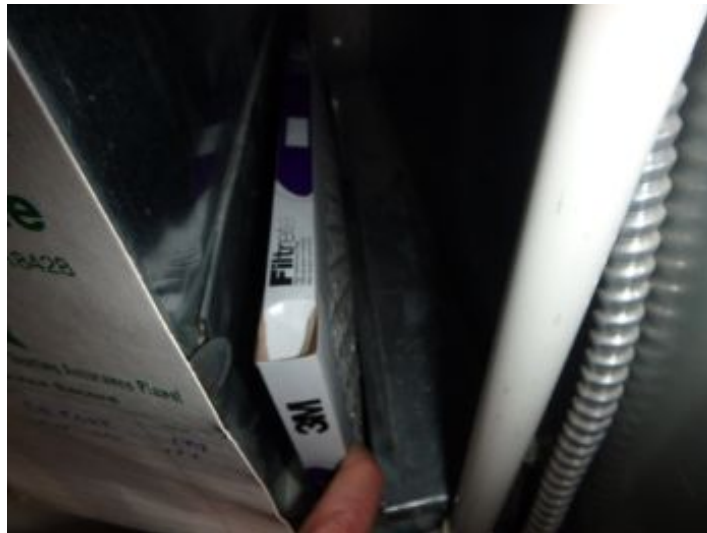
- No deficiencies noted.
- **MAINTENANCE:** The air filter(s) should be inspected at least monthly and cleaned or replaced as required. There are two types of filters commonly used: (1) Washable filters, (constructed of aluminum mesh, foam, or reinforced fibers) these may be cleaned by soaking in mild detergent and rinsing with water. Or (2) Fiberglass disposable filters that must be REPLACED before they become clogged. Remember that dirty filters are the most common cause of inadequate heating or cooling performance.

MAINTENANCE: The air filter(s) should be inspected at least monthly and cleaned or replaced as required. There are two types of filters commonly used: (1) Washable filters, (constructed of aluminum mesh, foam, or reinforced fibers) these may be cleaned by soaking in mild detergent and rinsing with water. Or (2) Fiberglass disposable filters that must be REPLACED before they become clogged. Remember that dirty filters are the most common cause of inadequate heating or cooling performance.

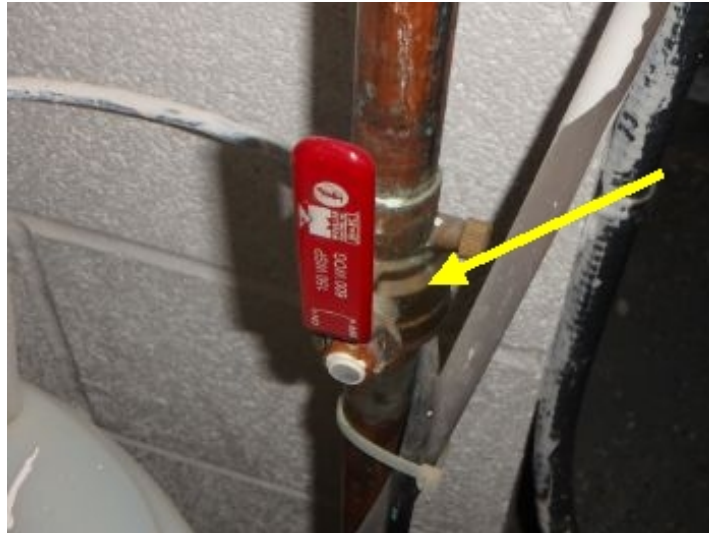
- Main water shutoff.

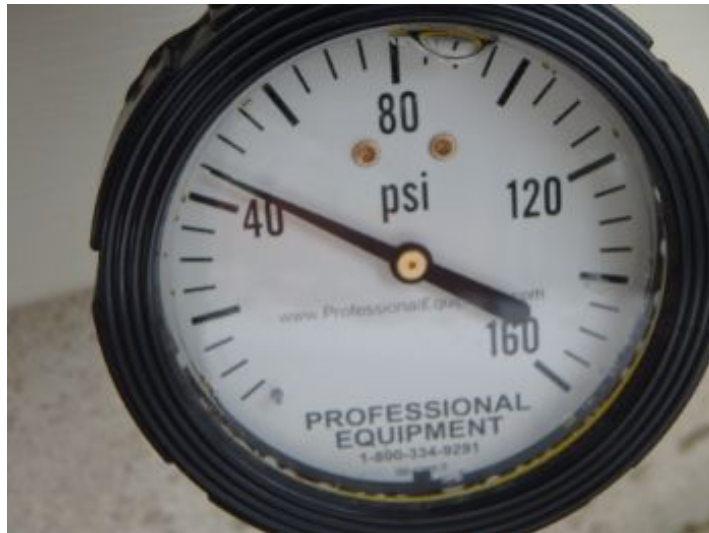
- The water flow was overall functional. This was determined by running water in the bath sink and shower while toilet is flushed.

The water flow was overall functional. This was determined by running water in the bath sink and shower while toilet is flushed.
